Manhole Inspection Summary

Manhole # S55C__013MH

Insp Date: **6/23/08 12:07 PM**

Location Address: **3800 e baltimore**

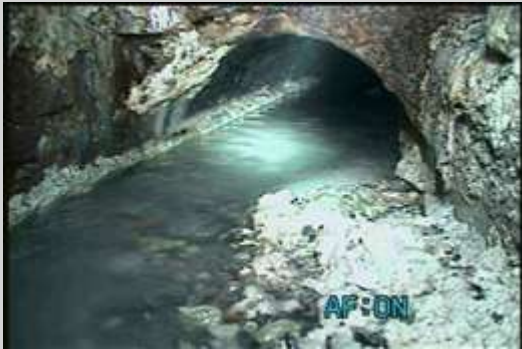
12 O'Clock Outflow

12 in. Circular Gravity Sewer
Pipe Out @ 12 O'Clock

Pipe Material: **Clay** ☐ Pipe Lined

Invert Depth: **19.03** (ft.) Flow Characteristics: **Fast**

Deposits: ☒ None ☐ Mud ☐ Sludge ☐ Debris ☐ Grease

Infiltration: **None** Pipe Seal Cond: **Unknown**

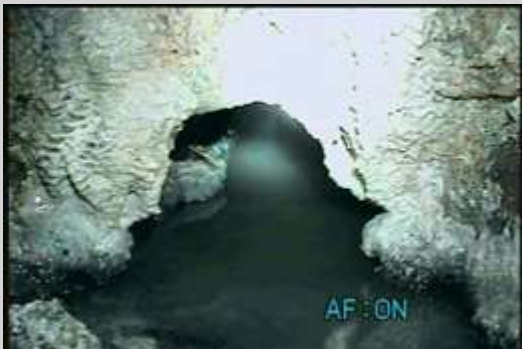
6 O'Clock Inflow

8 in. Circular Gravity Sewer
Pipe In @ 6 O'Clock

Pipe Material: **Clay** ☐ Pipe Lined

Invert Depth: **19.02** (ft.) Flow Characteristics: **Slow**

Deposits: ☒ None ☐ Mud ☐ Sludge ☐ Debris ☐ Grease

Infiltration: **None** Pipe Seal Cond: **Unknown**

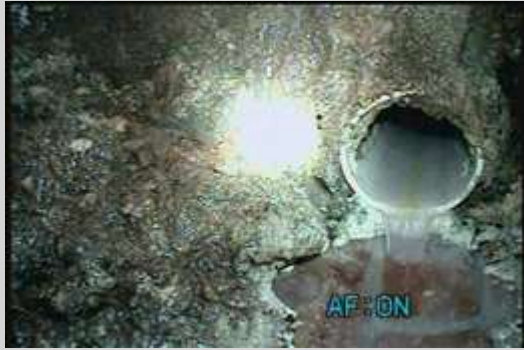
9 O'Clock Inflow

8 in. Circular Gravity Sewer

Pipe In @ 9 O'Clock

Pipe Material: **PVC** ☐ Pipe Lined

Infiltration: **None**
